# Manhole Inspection Summary

Manhole # S33GG1010MH

**Location** Address: **6 HADLEY SQ**

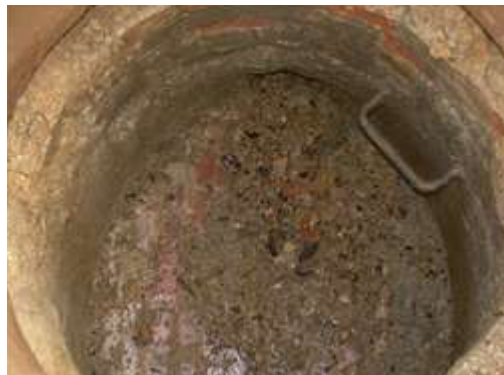
Top View

Channel debris.

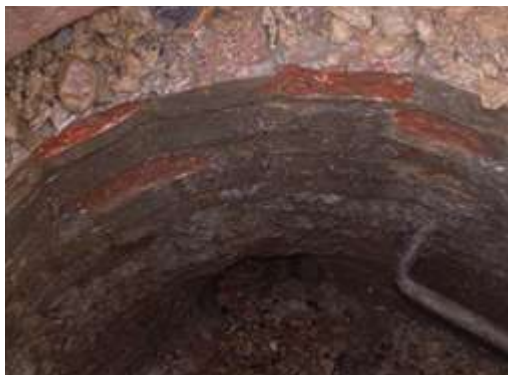
Defect

Frame leaks. Frame offset. Adjustment deterioration and infiltration.

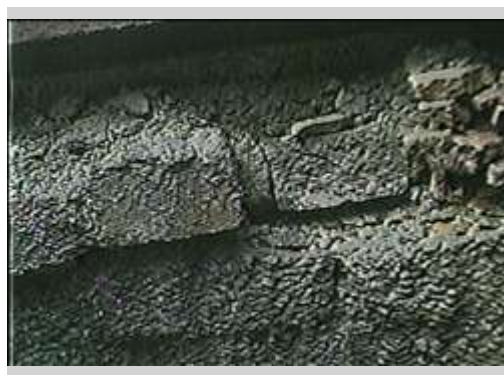
Defect

Adjustment deterioration

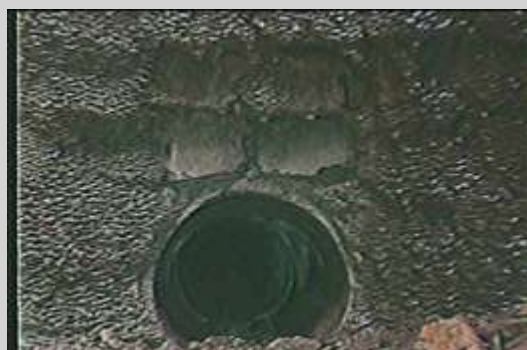
Barrel deterioration and infiltration.
